**NEW MEXICO
ENVIRONMENT DEPARTMENT**

Re: Sonoma Ranch East II/Sonoma Ranch East Phase 9; CGP; SIC 1521; NPDES Compliance Evaluation Inspection; NPDES #NMR1000NV; February 13, 2019

NPDES Construction General Permit Inspection Report – State of New Mexico

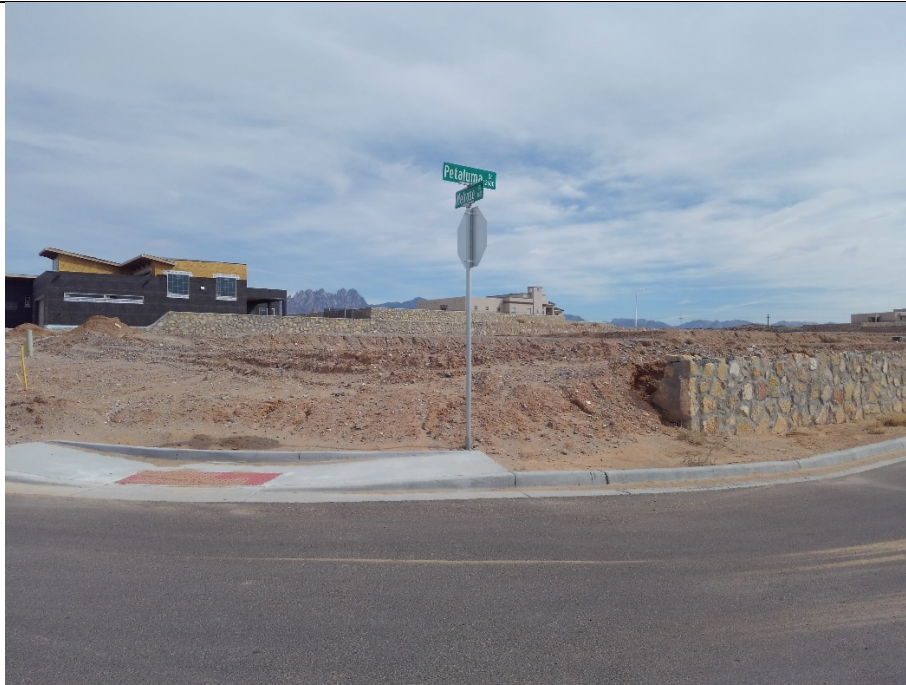
NMED/SWQB Official Photograph Log Photo # 2		
Photographer: Jennifer Foote	Date: 2/13/19	Time: 1:09 pm
City/County: Las Cruces/ Dona Ana		State: New Mexico
Location: Sonoma Ranch Phase 9		
Subject: Berm on property edge with erosion

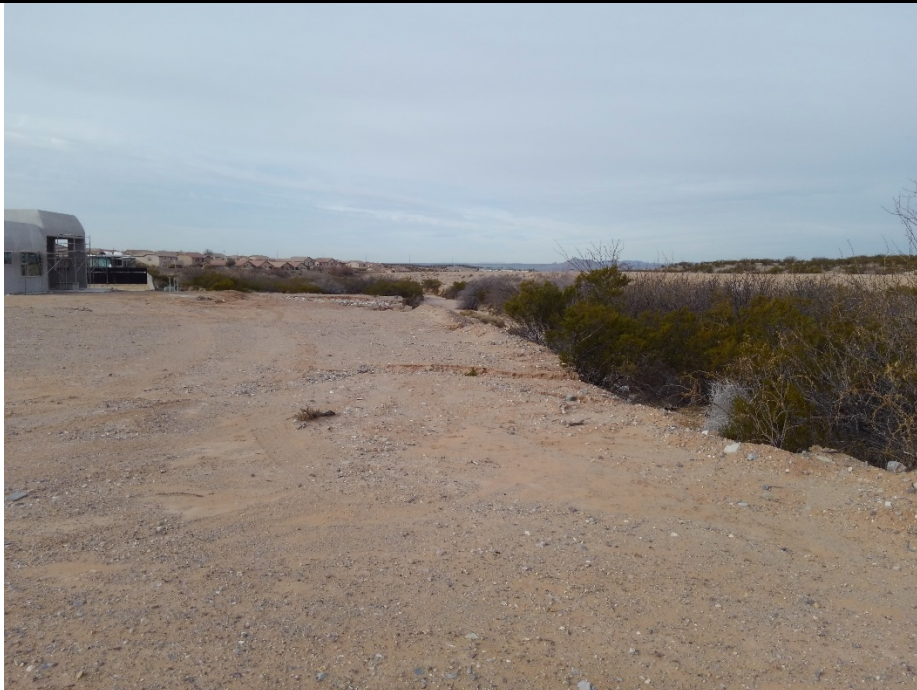
NMED/SWQB Official Photograph Log Photo # 3		
Photographer: Jennifer Foote	Date: 2/13/19	Time: 9:08 am
City/County: Las Cruces/ Dona Ana		State: New Mexico
Location: Sonoma Ranch Phase 9		
Subject: Berm on property edge with erosion

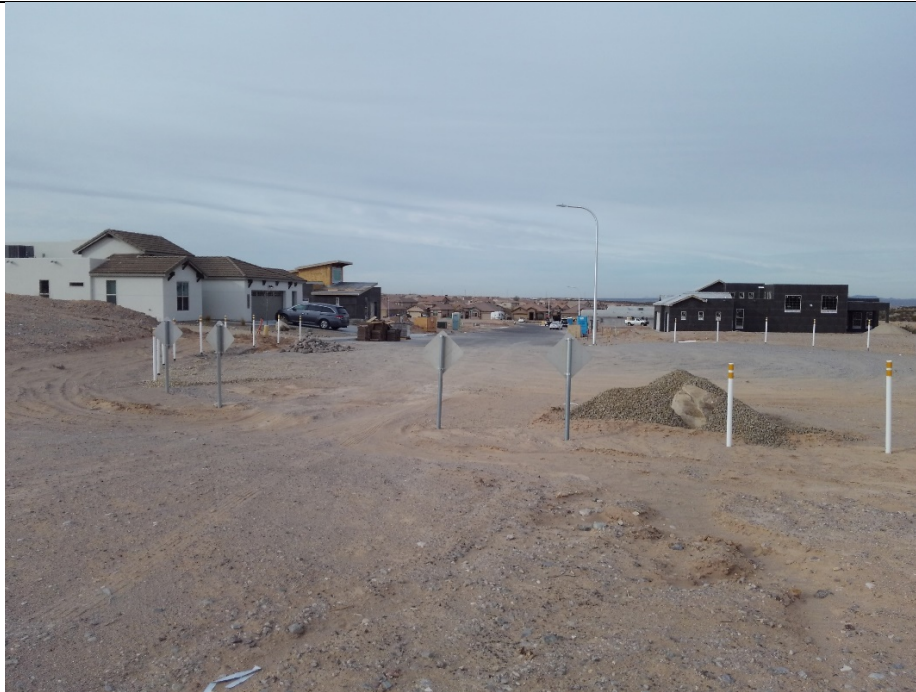
NMED/SWQB Official Photograph Log Photo # 4		
Photographer: Jennifer Foote	Date: 2/13/19	Time: 8:49am
City/County: Las Cruces/ Dona Ana		State: New Mexico
Location: Sonoma Ranch Phase 9		
Subject: no perimeter BMPs between east area and stabilized road on west portion of site

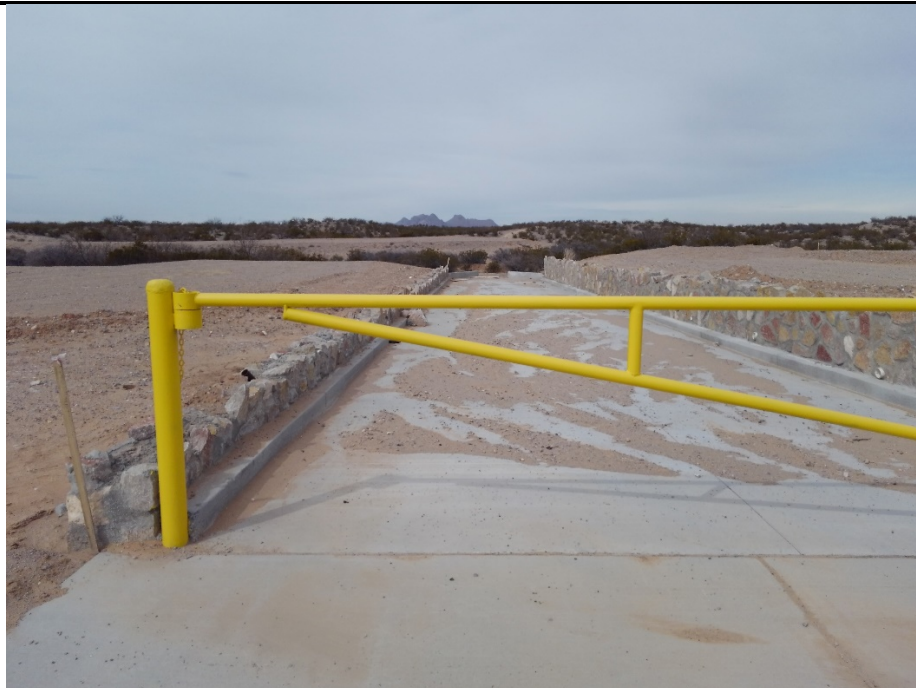
NMED/SWQB Official Photograph Log Photo # 5		
Photographer: Jennifer Foote	Date: 2/13/19	Time: 1:03pm
City/County: Las Cruces/ Dona Ana		State: New Mexico
Location: Sonoma Ranch Phase 9		
Subject: no BMPs to prevent sediment from entering storm drain

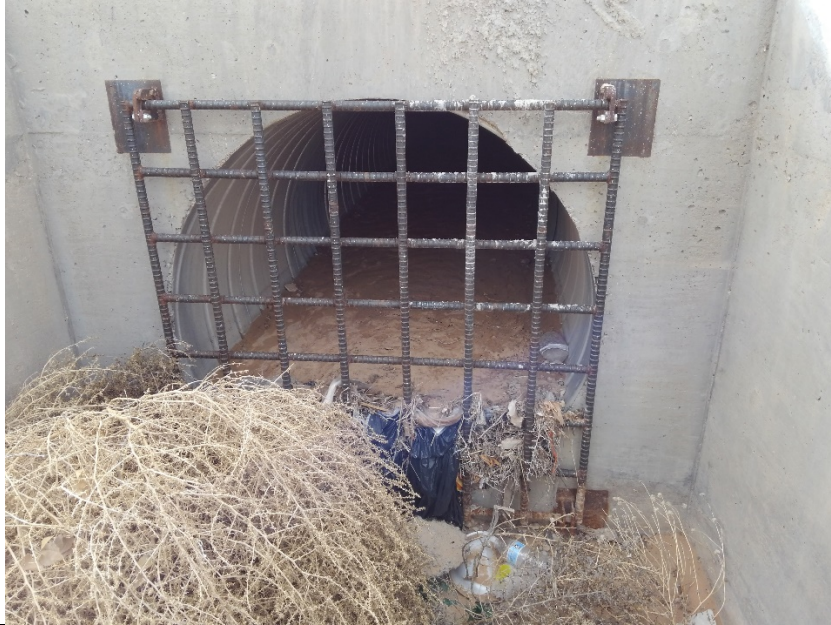
NMED/SWQB Official Photograph Log Photo #6		
Photographer: Jennifer Foote	Date: 2/13/19	Time: 9:06am
City/County: Las Cruces/ Dona Ana		State: New Mexico
Location: Sonoma Ranch Phase 9		
Subject: Storm drain outlet with several inches of sediment inside

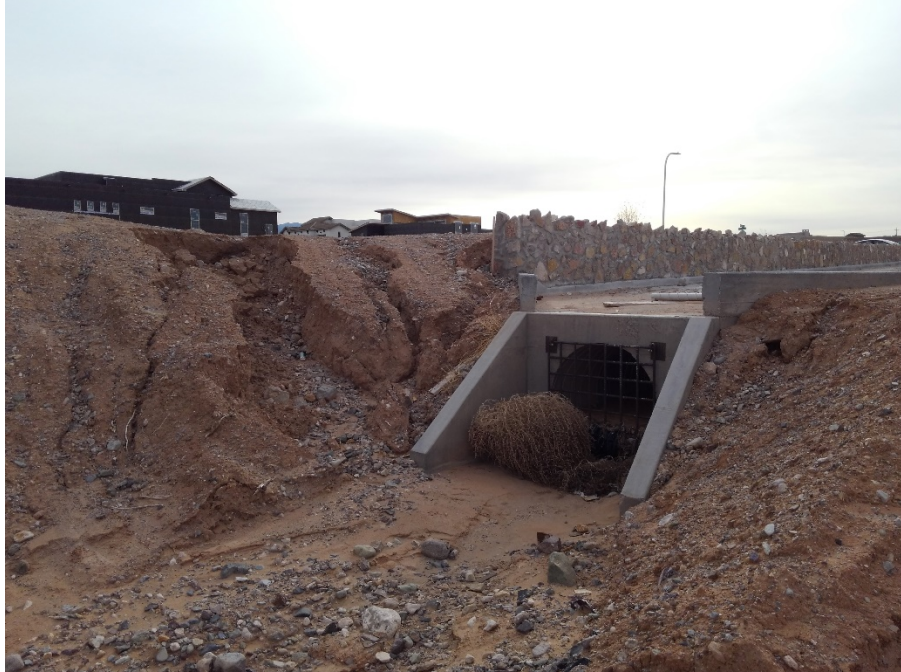
In general, the BMPs were limited to a 6 month tackifier application and a berm around the lot as perimeter control. It appeared that several berms were not adequate to contain flows off the site and had not been maintained after installation (photo 2, 3). The eastern portion of the site had no perimeter controls and sediment laden runoff could discharge to the road and the storm drainage system (photo 4). No BMPs were installed to prevent sediment from entering storm drains (photo 5,8). Rock had been installed at the end of culverts, but erosion was occurring adjacent to them indicating inadequate sizing and one had been overwhelmed by sediment (photo 7-11).

The Site map included a note that a co-polymer with 6 month treatment should be used on all disturbed surfaces. It also included a note that a native hydroseed mixture will be applied on all slopes. No information on date applied, type, amount, longevity of tackifiers used for temporary stabilization was included in the plan. It did not appear that slopes had been seeded (photo 7, 8, 10).

NMED/SWQB Official Photograph Log Photo # 7		
Photographer: Jennifer Foote	Date: 2/13/19	Time: 9:05am
City/County: Las Cruces/ Dona Ana		State: New Mexico
Location: Sonoma Ranch Phase 9		
Subject: Erosion adjacent to storm drain outlet, outlet stabilization is choked with sediment, no evidence of seeding on slopes

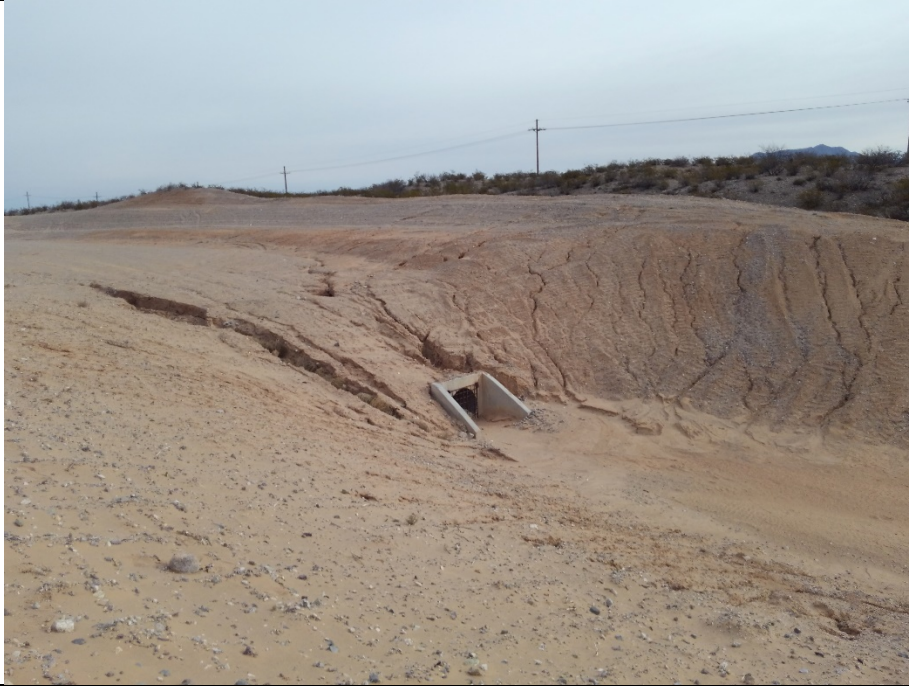
NMED/SWQB Official Photograph Log Photo # 8		
Photographer: Jennifer Foote	Date: 2/13/19	Time: 8:53am
City/County: Las Cruces/ Dona Ana		State: New Mexico
Location: Sonoma Ranch Phase 9		
Subject: Erosion adjacent to storm drain inlet, no inlet protection, no evidence of seeding on slopes

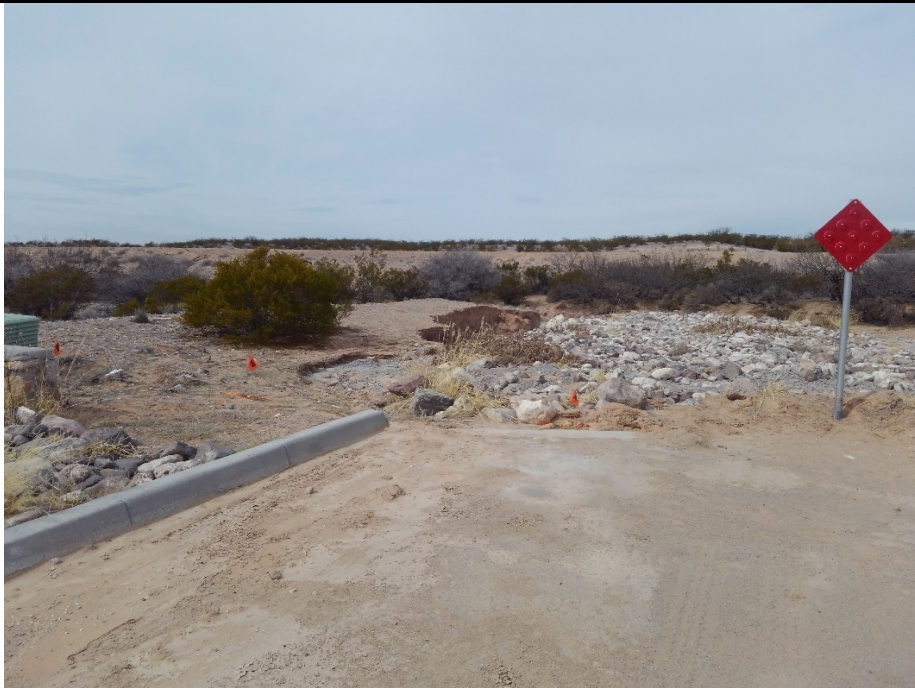
NMED/SWQB Official Photograph Log Photo # 9		
Photographer: Jennifer Foote	Date: 2/13/19	Time: 1:05pm
City/County: Las Cruces/ Dona Ana		State: New Mexico
Location: Sonoma Ranch Phase 9		
Subject: Erosion around outlet protection

Response: A substantial velocity dissipation structure was installed at the north center Melrose Road outlet on March 03, 2019 in accordance with City of Las Cruces approved construction plans. See attachment 2 “Rock dissipation” photo. The two outlet velocity dissipation structures (riprap) 500’ to the east of this outlet were built to City of Las Cruces approved plans. The Owner and City are addressing these concerns together for a solution to the embankments at this location.

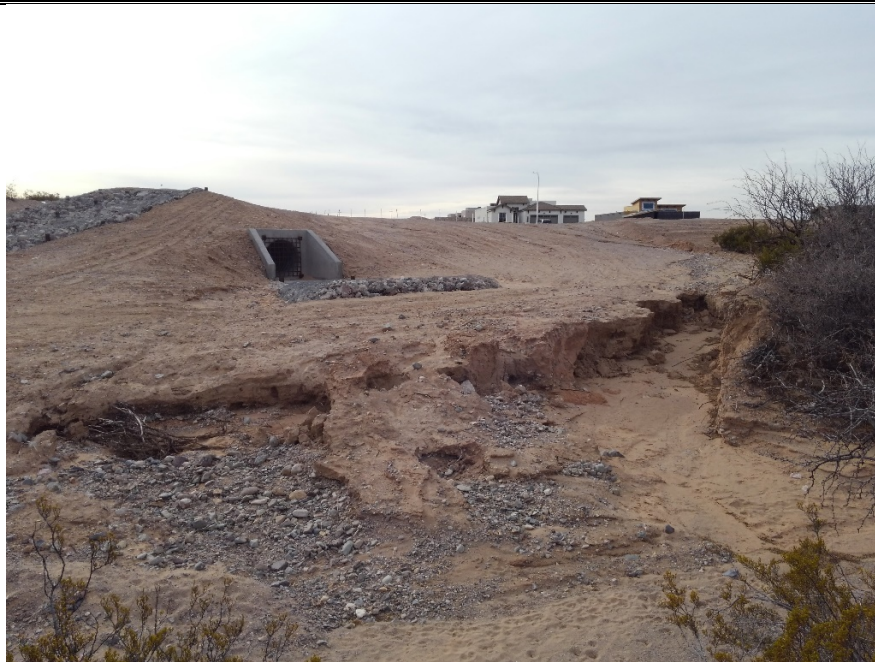
NMED/SWQB Official Photograph Log Photo # 10		
Photographer: Jennifer Foote	Date: 2/13/19	Time: 9:01am
City/County: Las Cruces/ Dona Ana		State: New Mexico
Location: Sonoma Ranch Phase 9		
Subject: Erosion after outlet protection

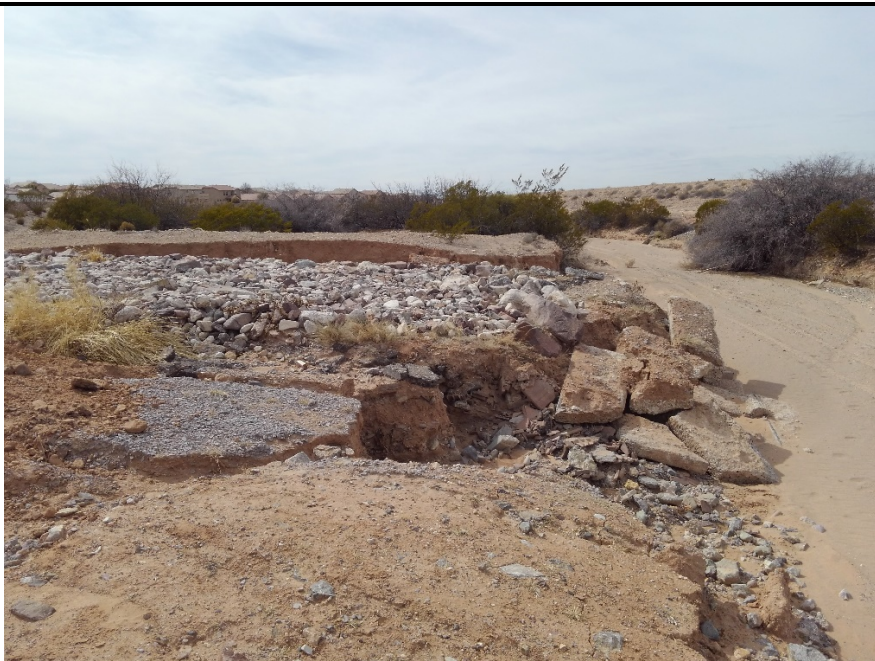
NMED/SWQB Official Photograph Log Photo # 11		
Photographer: Jennifer Foote	Date: 2/13/19	Time: 1:07pm
City/County: Las Cruces/ Dona Ana		State: New Mexico
Location: Sonoma Ranch Phase 9		
Subject: Erosion around outlet protection
